# Debris/Ice/TPS Assessment And Photographic Analysis For Shuttle Mission STS-42

March 1992

National Aeronautics and  
Space Administration

**Gregory N. Katnik**  
**NASA/Kennedy Space Center**

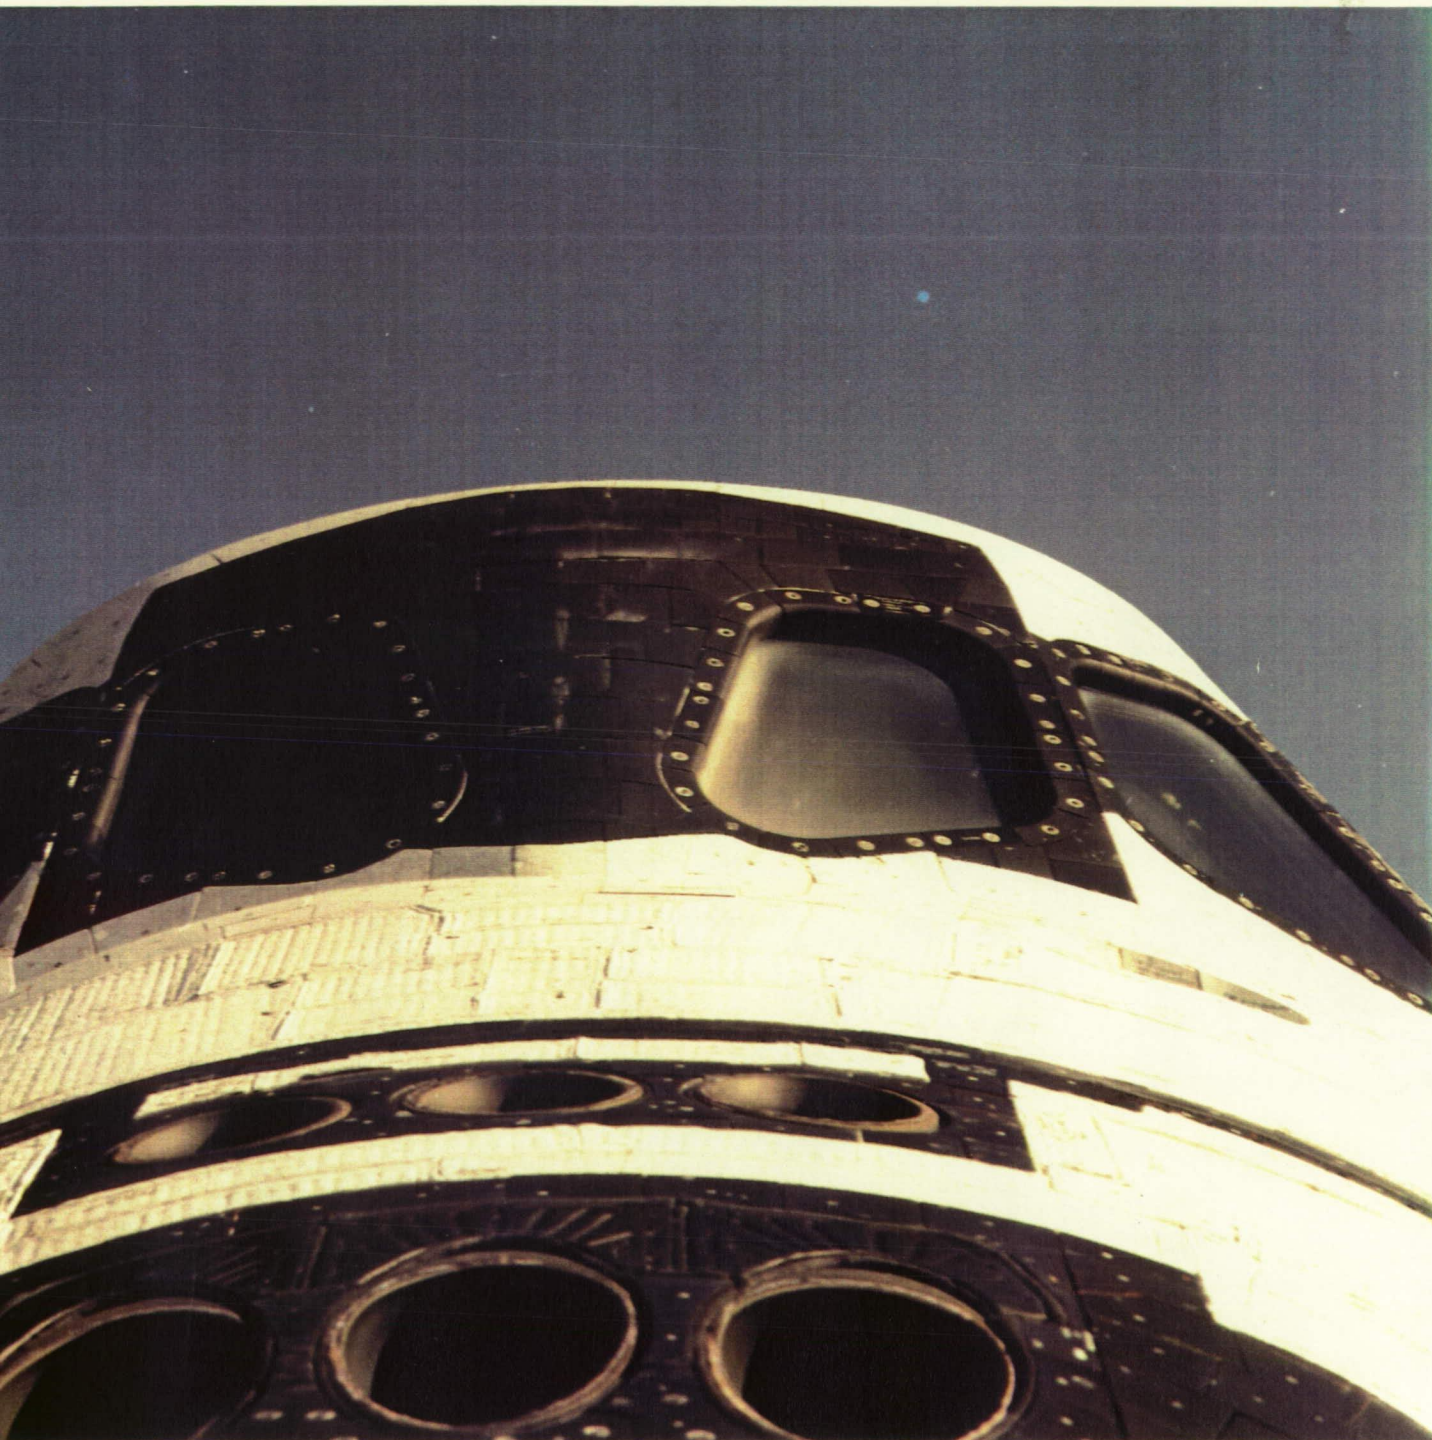
All Orbiter windows exhibited typical hazing. A few small streaks were present on windows #3 and #4

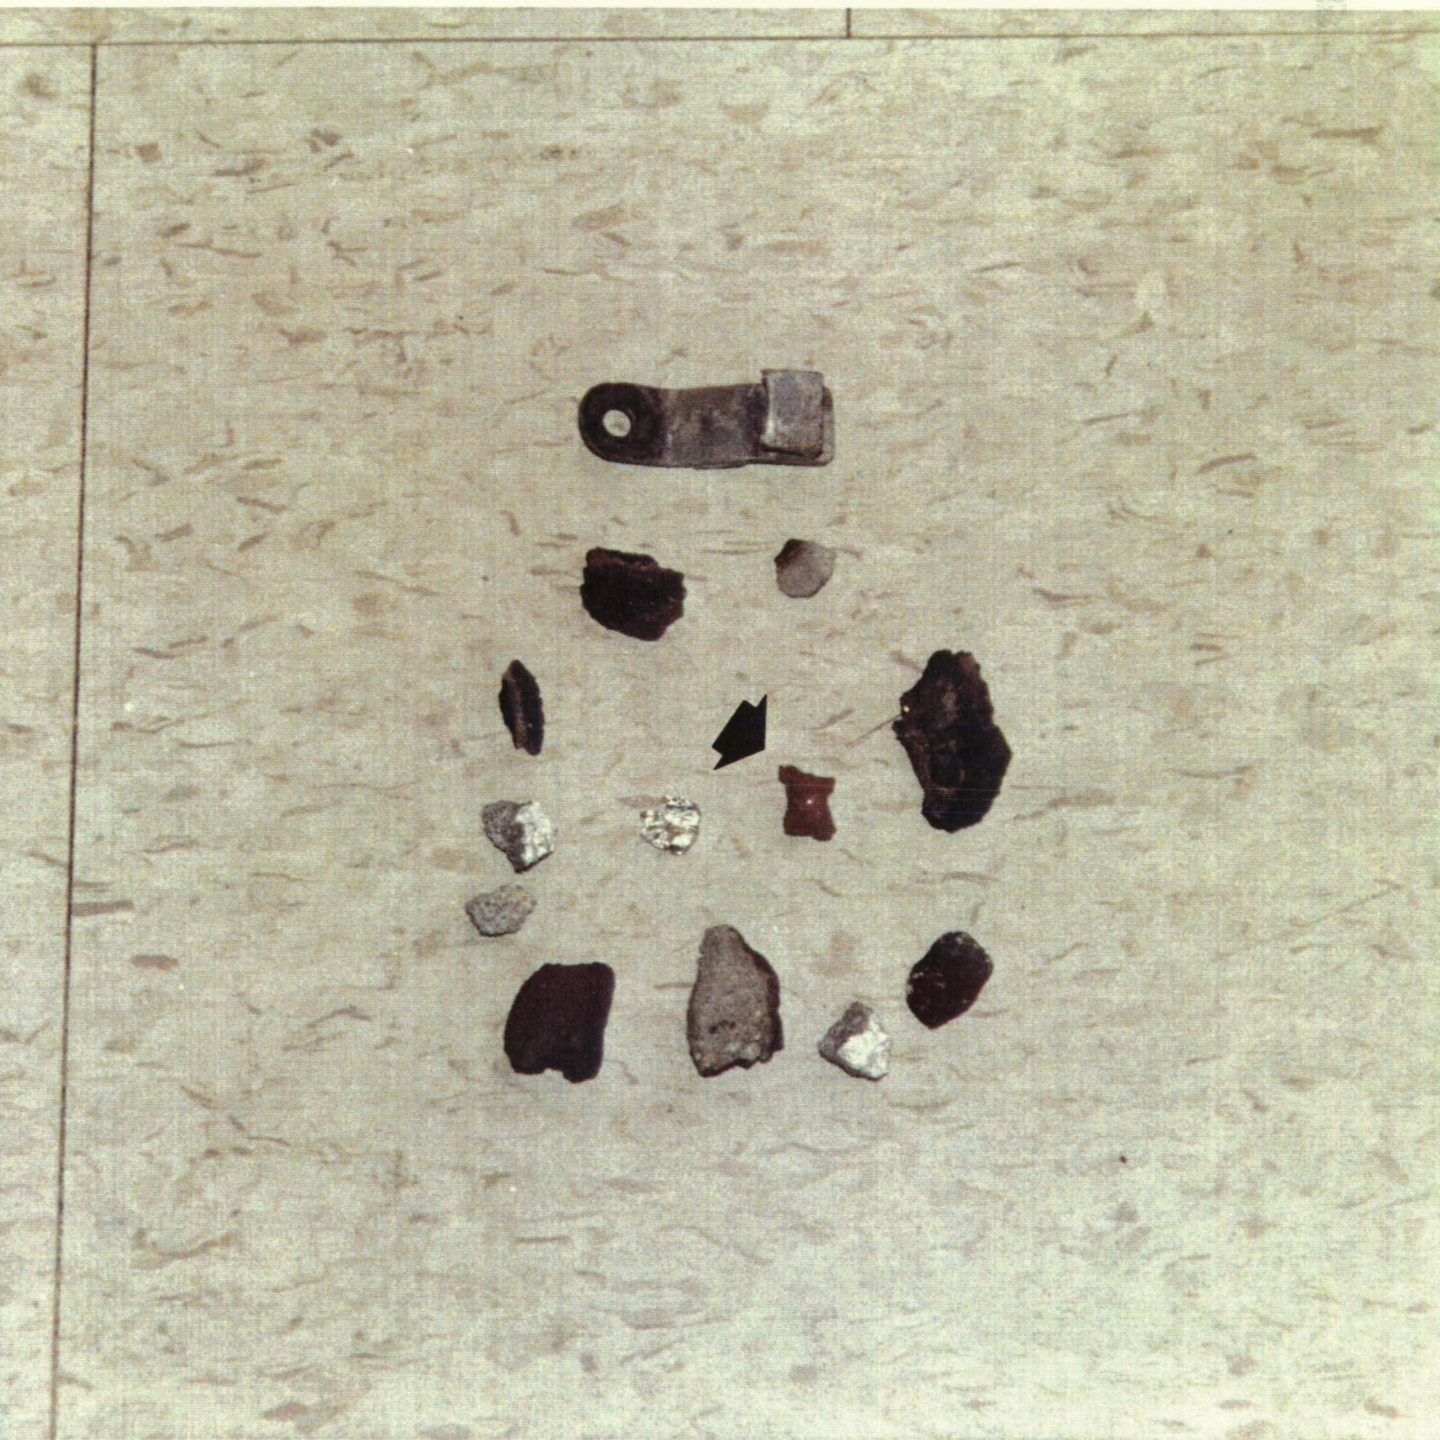
Typical debris found on the runway after landing. The only flight hardware recovered was a small piece of red RTV rubber material from the LH inboard main landing gear tire strain gage wire harness.

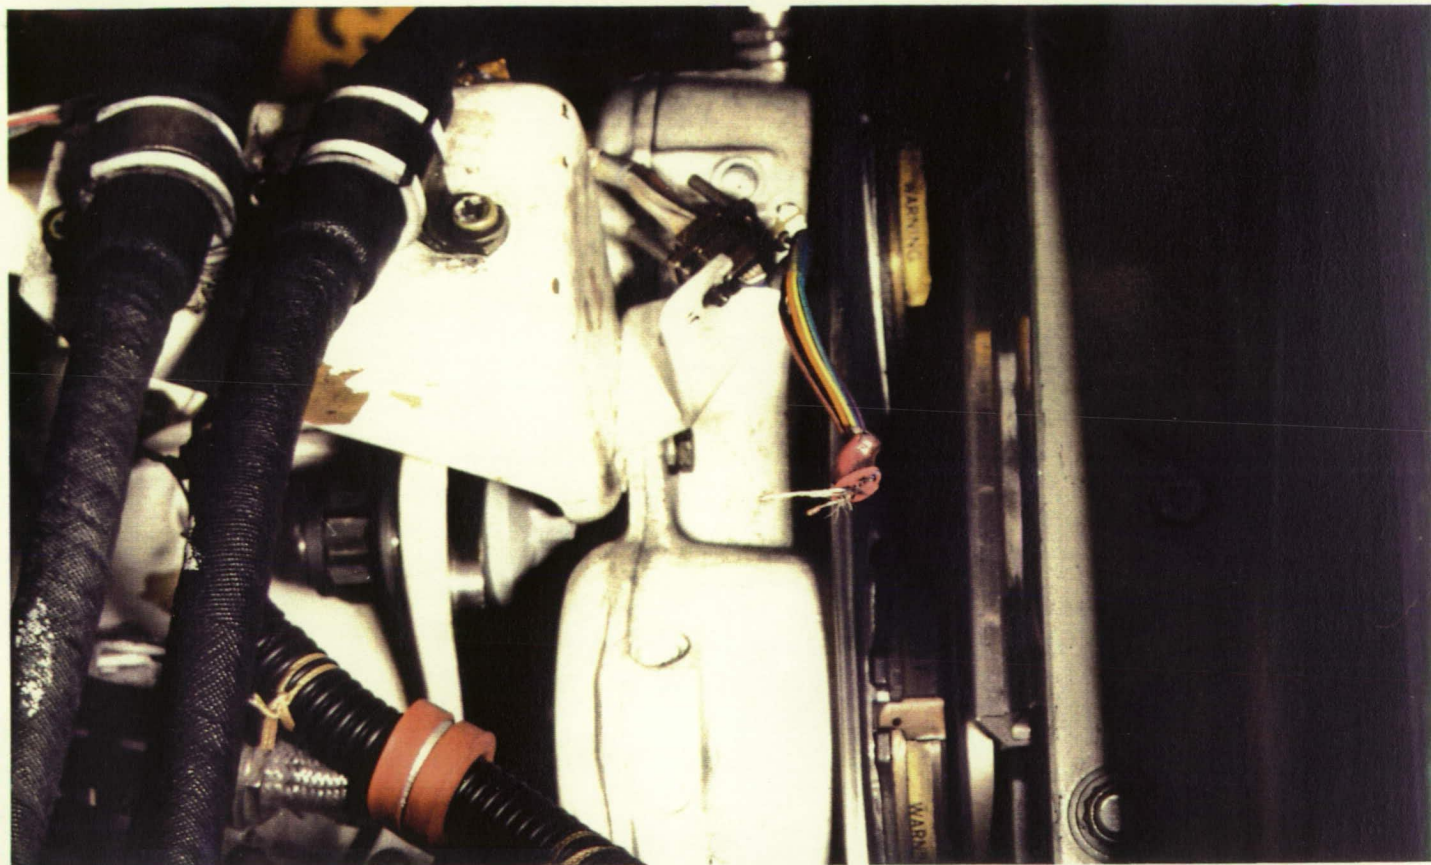
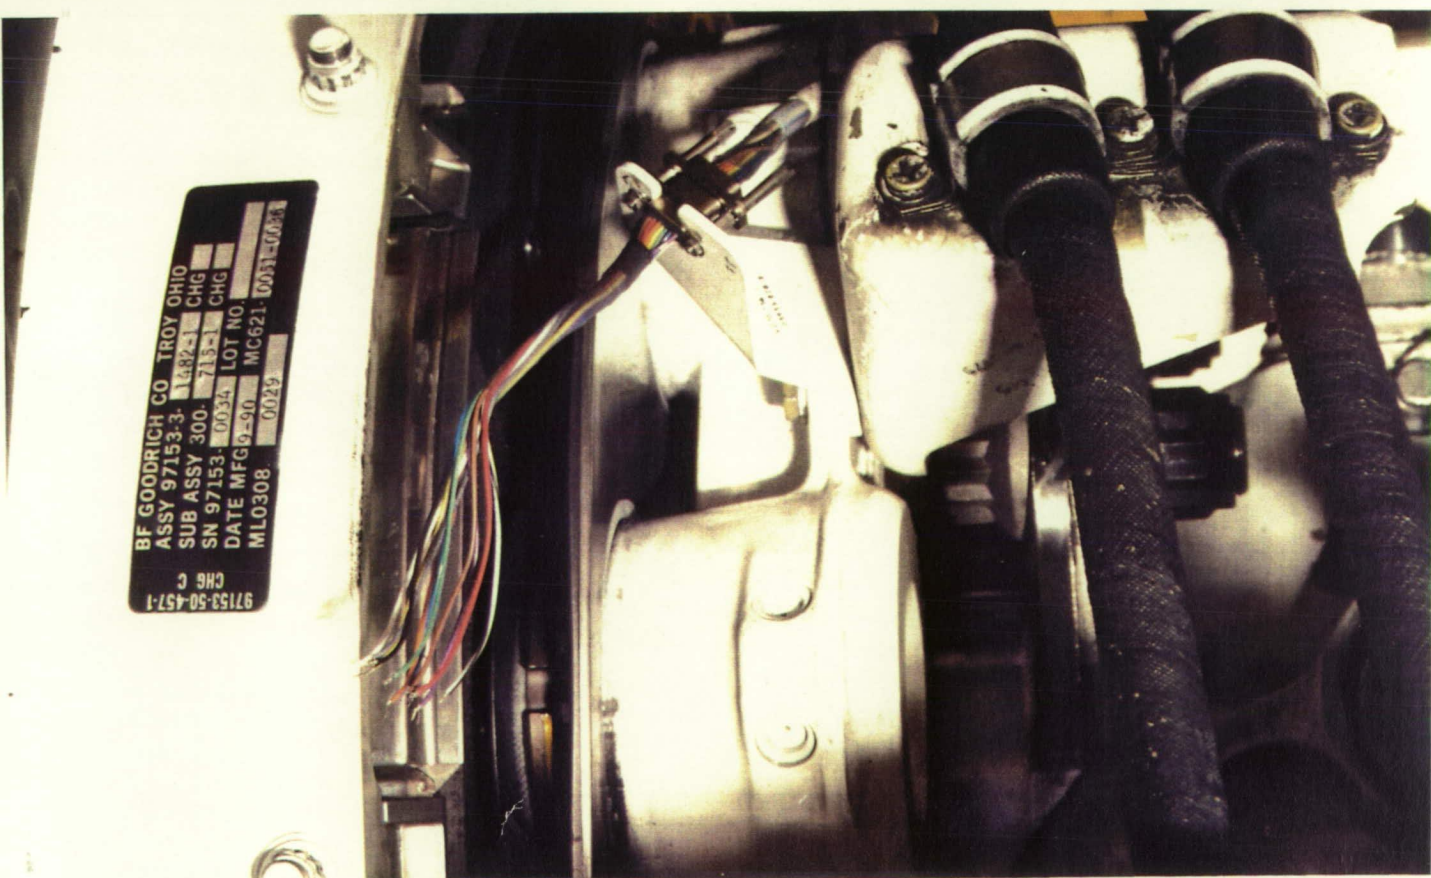
Comparative views showing small piece of RTV rubber material attached to strain gage wires (nominal configuration) and missing RTV from wires on the LH inboard main landing gear.
